Fathom

The Naval Safety Center's Afloat Magazine

July-September 2003

Volume 35, Number 3

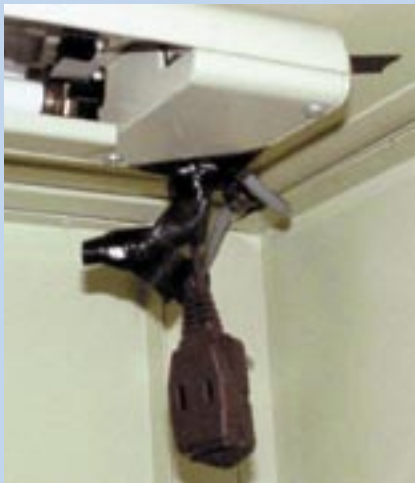
Here a Sailor just cut off the female end of a cheap extension cord and tapped into a bunk light's voltage input line.

After tagging out all the compartment bunk lights, electrician’s mates identified and repaired each modified light. Repairs took a month, and each altered bunk light was photographed to document the range and varied skills used for the unauthorized alterations. [See photos on next page.]

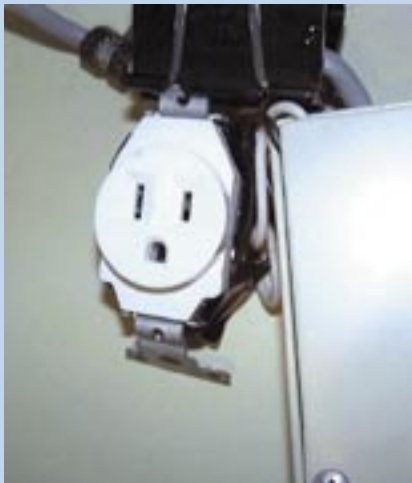
A single wall outlet was used for this dangerous supplemental plug showing numerous exposed wires.

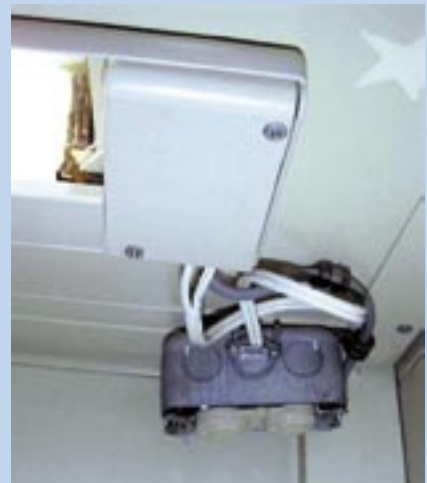
Although appearing sturdy and showing some ingenuity, this double wall outlet didn't even have a cover.

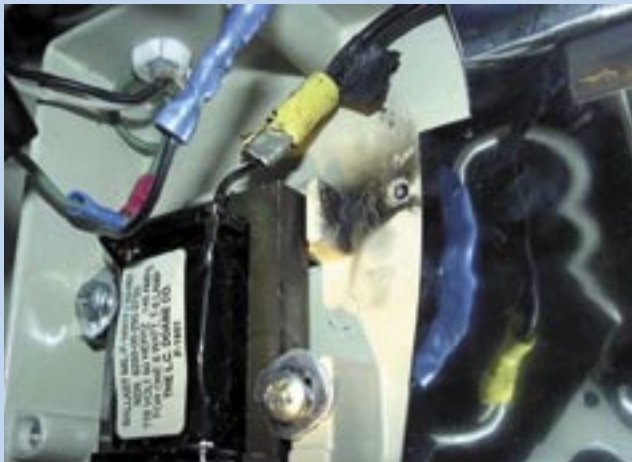
This photo shows the results of arcing where a Sailor tapped into the voltage lines of a ballast transformer.

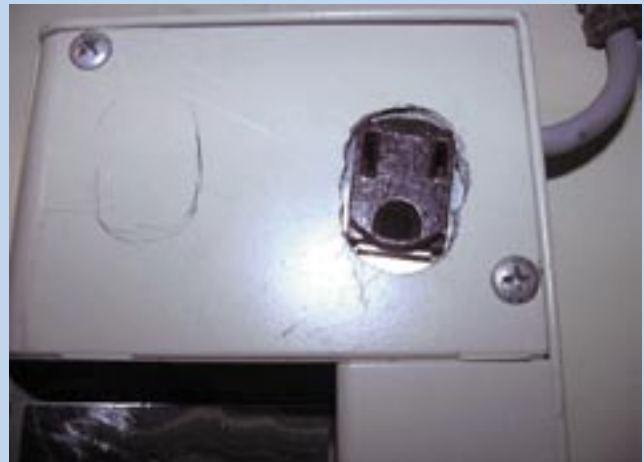
A Sailor tried to recess a plug by cutting a hole into the protective plate covering the input power cord.

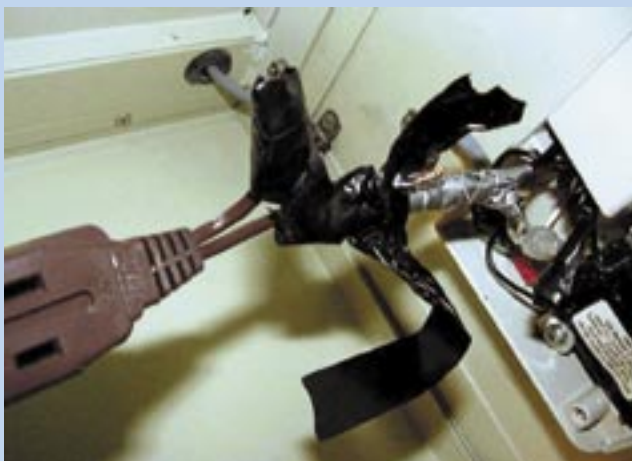
A combination of "spaghetti" wiring and electrical tape, this contraption even looks forbidding.

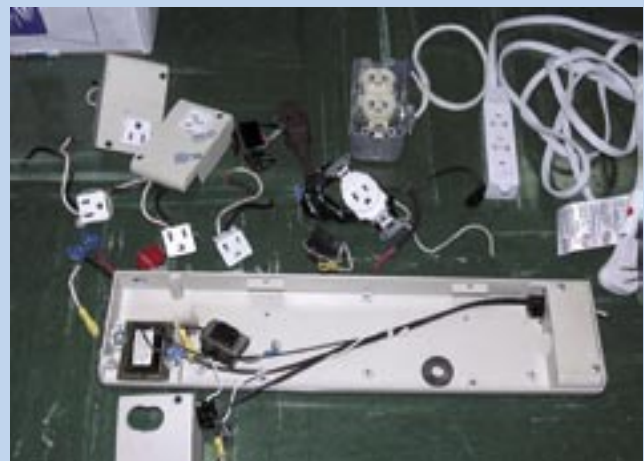
This is a mixture of some of the jerry-rigs to bunk lights found shortly before the ship deployed.

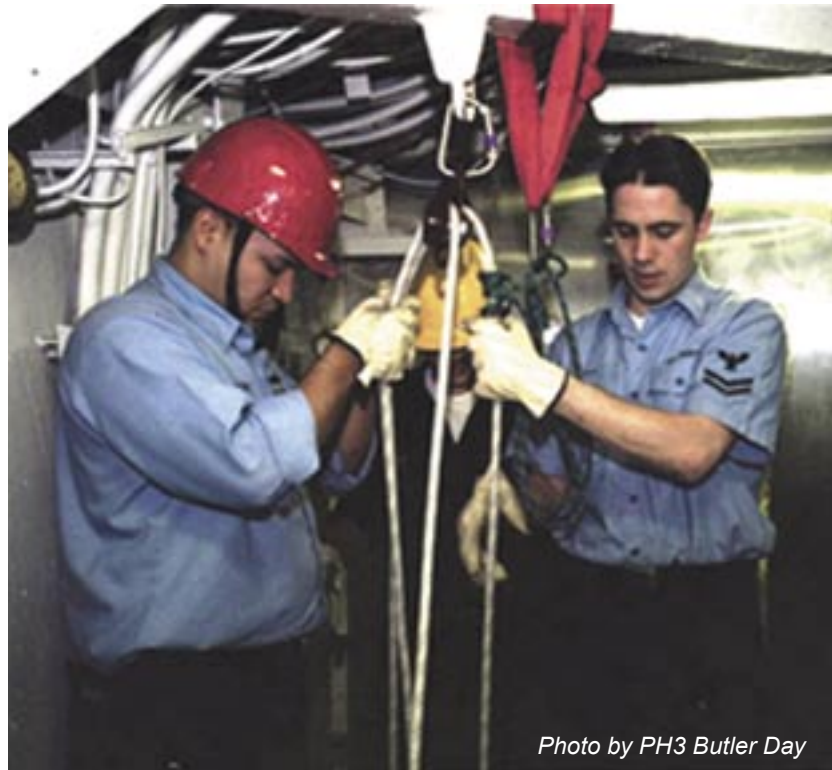
DC1(SW) Elis Robles (left) and DC2 Brendan B. Scott watch the lines as they practice bringing an injured Sailor from the lower decks of USS *Enterprise* (CVN 65) topside. As part of the ship's fire and rescue team, learning deep rescue techniques is becoming a necessary part of shipboard training.

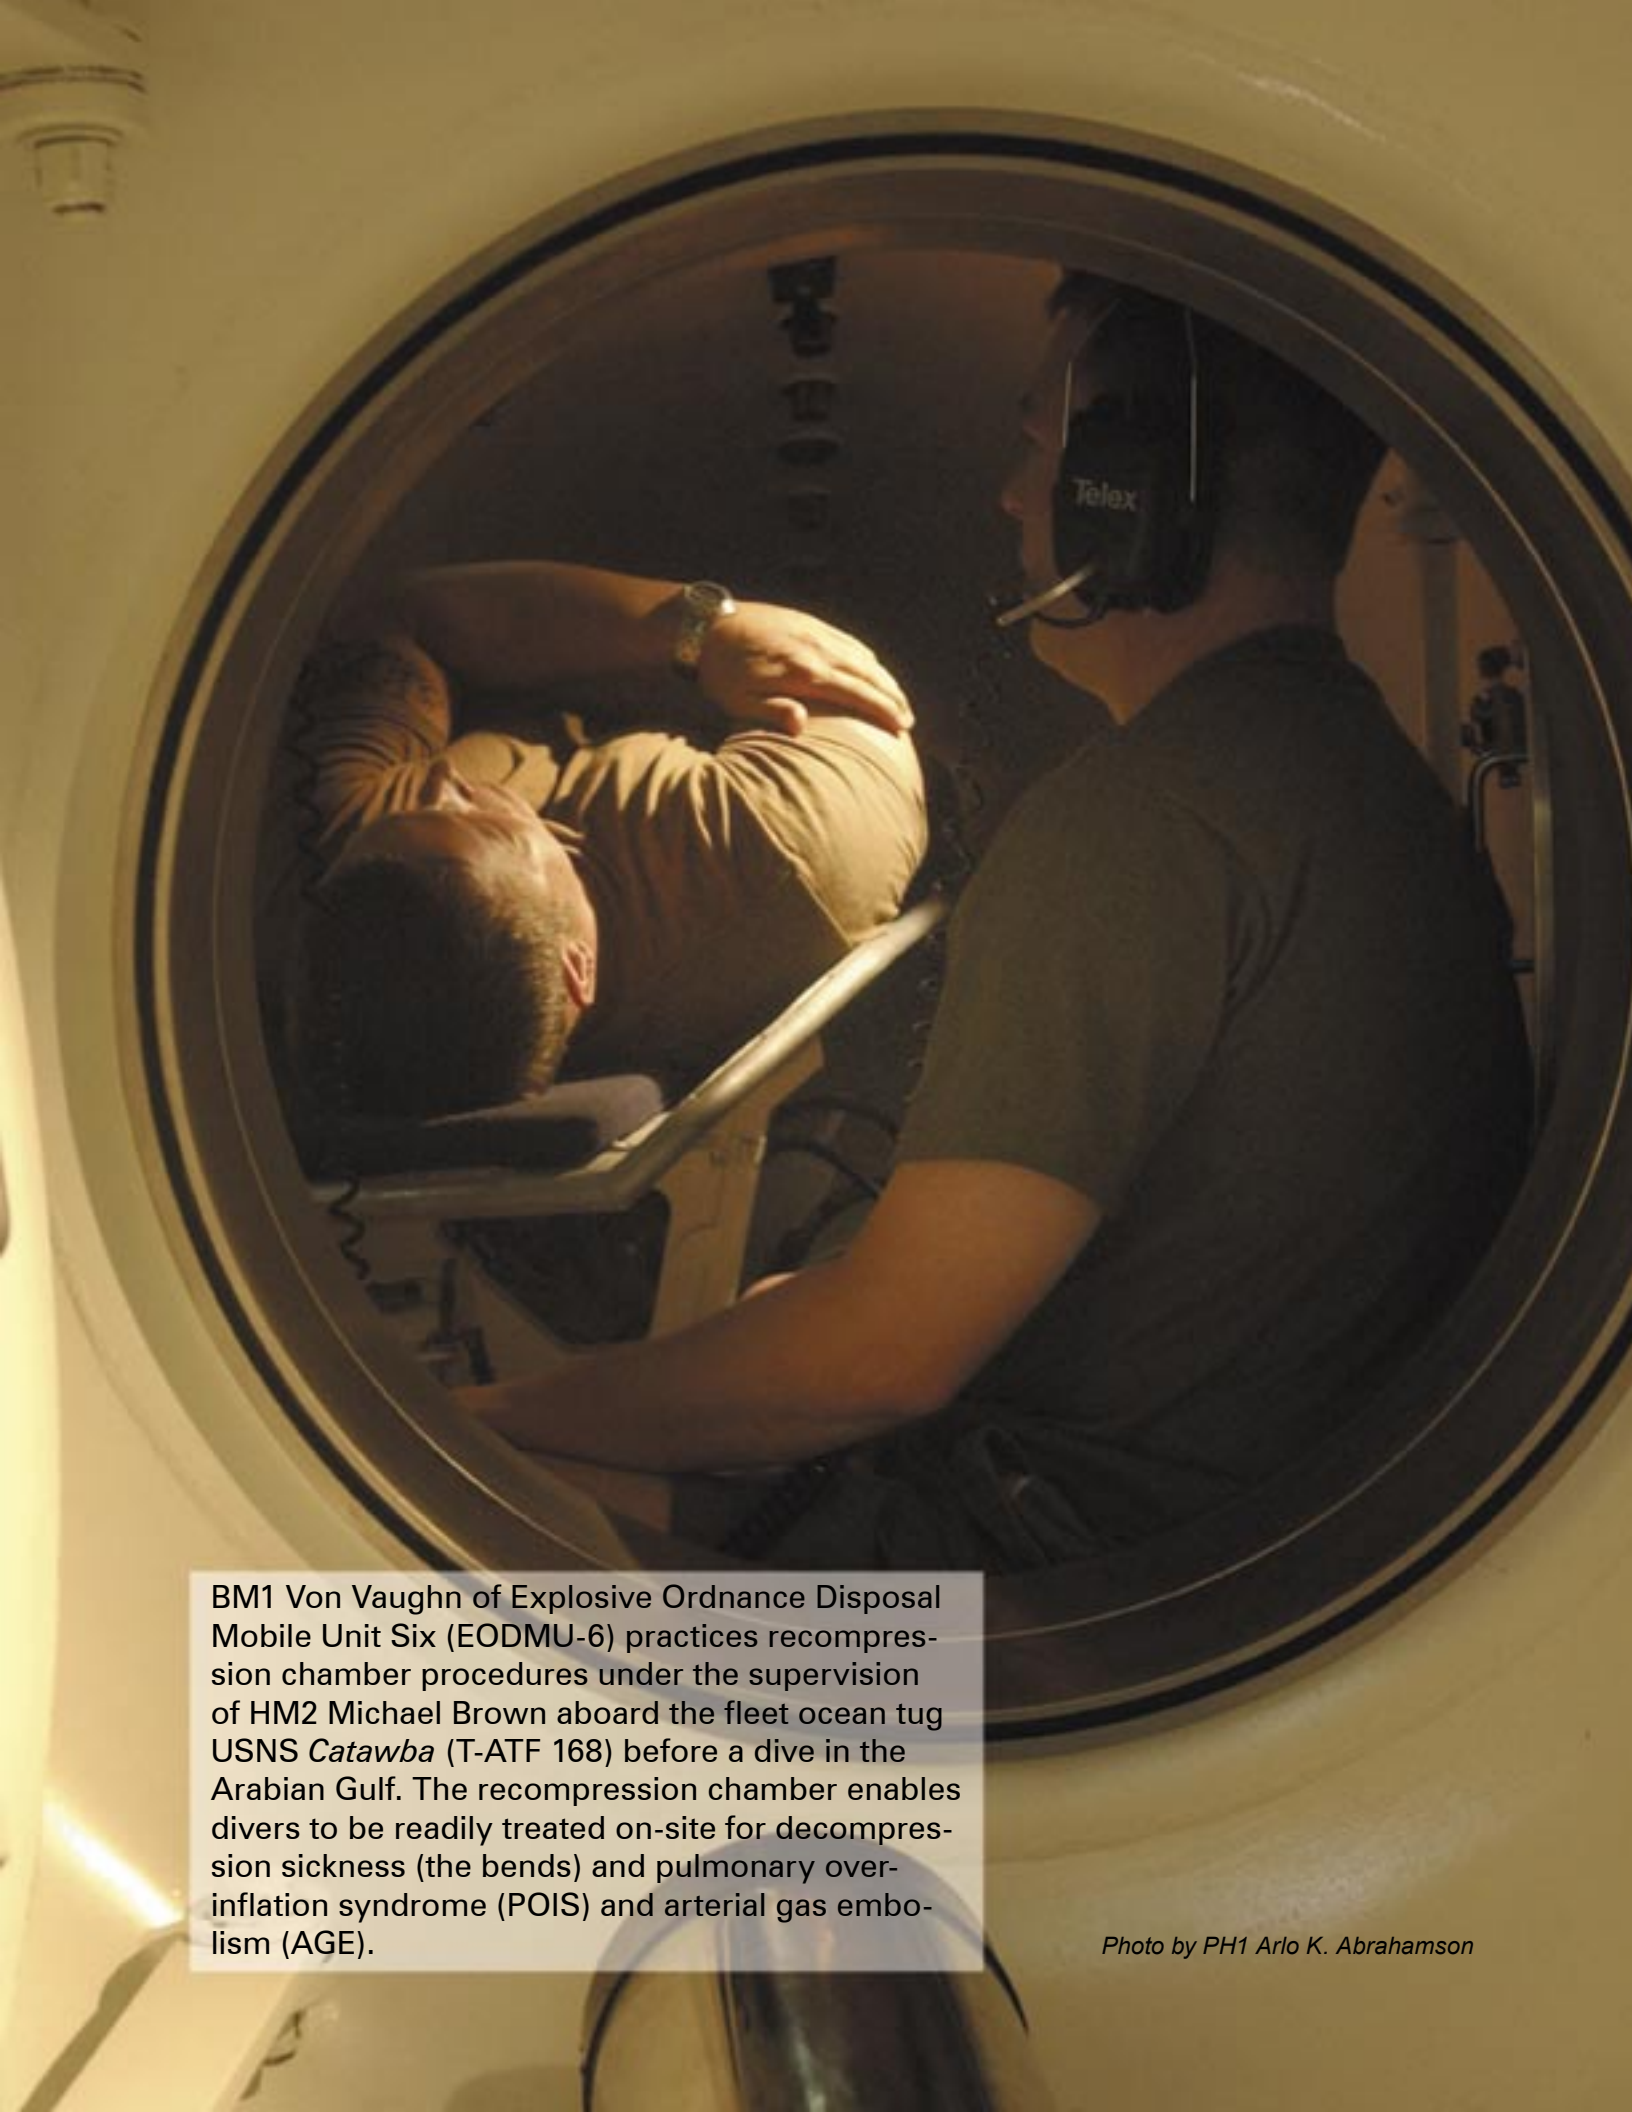
BM1 Von Vaughn of Explosive Ordnance Disposal Mobile Unit Six (EODMU-6) practices recompression chamber procedures under the supervision of HM2 Michael Brown aboard the fleet ocean tug USNS *Catawba* (T-ATF 168) before a dive in the Arabian Gulf. The recompression chamber enables divers to be readily treated on-site for decompression sickness (the bends) and pulmonary over-inflation syndrome (POIS) and arterial gas embolism (AGE).
